1.0 Problem Reported by Customer

3.0 Results of Inspection and Testing

4.0 Analysis and Conclusions

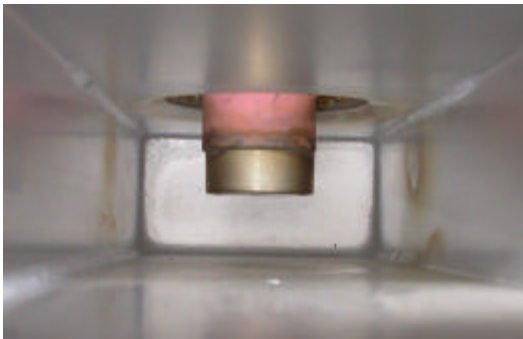
Photo 1

Evidence of arcing inside waveguide at the magnetron antenna (photo 1). Vacuum seal broken at antenna (photo 2). No evidence of arcing along the length of the waveguide.

Arcing between the antenna and waveguide can only be caused by an excessively high electric field at the magnetron antenna. The only possible causes are a high level of reverse power (high VSWR) or an arc that originated somewhere down the waveguide which would then have traveled to the magnetron antenna (arcing in waveguide always tends to travel toward the magnetron). Once established between the antenna and waveguide, arcing would have been sustained as long as microwave power was being generated.

The microwave generator in which this magnetron was used should never be operated without the use of a 2-port waveguide isolator (or 3-port circulator and dummy load) to protect the magnetron from reverse power. Since a circulator and dummy load were delivered along with the generator, it is presumed these components were installed in a system configuration for magnetron protection as described in the respective product user manuals that were delivered with the equipment. However, it is possible that protection may have been compromised if water flow in the dummy load was not provided according to instructions. The use of a water flow interlock device can help prevent damage due to lack of water flow.

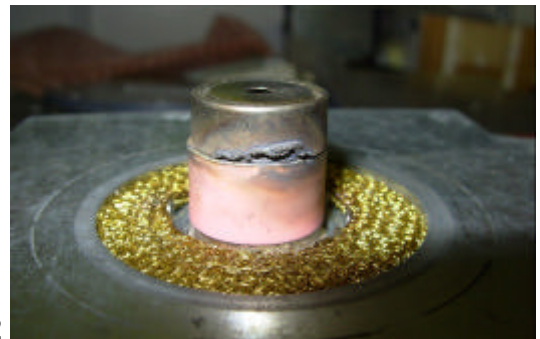
Photo 2

The sustained arcing eventually caused failure of the vacuum seal between the ceramic antenna body and metal cap. The sudden inrush of air (oxygen) inside the magnetron body while the filament and anode were at full operating temperature allowed rapid oxidation of the heated metal surfaces. Since the filament voltage was still being applied, the filament quickly overheated until melting and thus creating the open circuit.

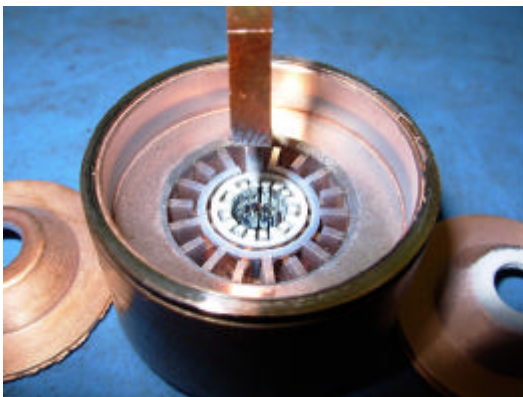
Photo 3

The magnetron was disassembled and internally inspected. Heavy oxidation was found on the anode vanes and straps (photos 3 and 4). No deformation of the anode or antenna structures was found.

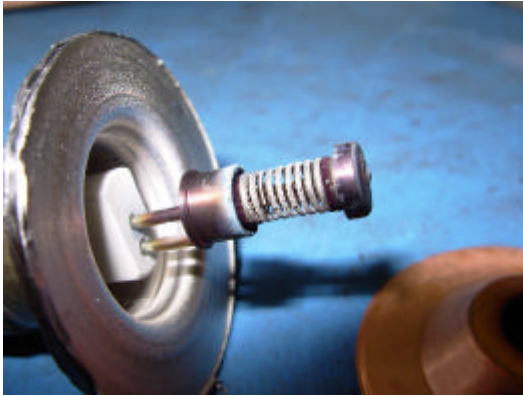
Photo 5

Heavy oxidation was also found on the filament, as well as evidence of the open filament wire (photo 5). The filament wire is otherwise fully intact and shows no other indication of deformation.
